Low-Cost Shore Protection

Final Report on the Shoreline Erosion Control
Demonstration Program (Section 54)
1981

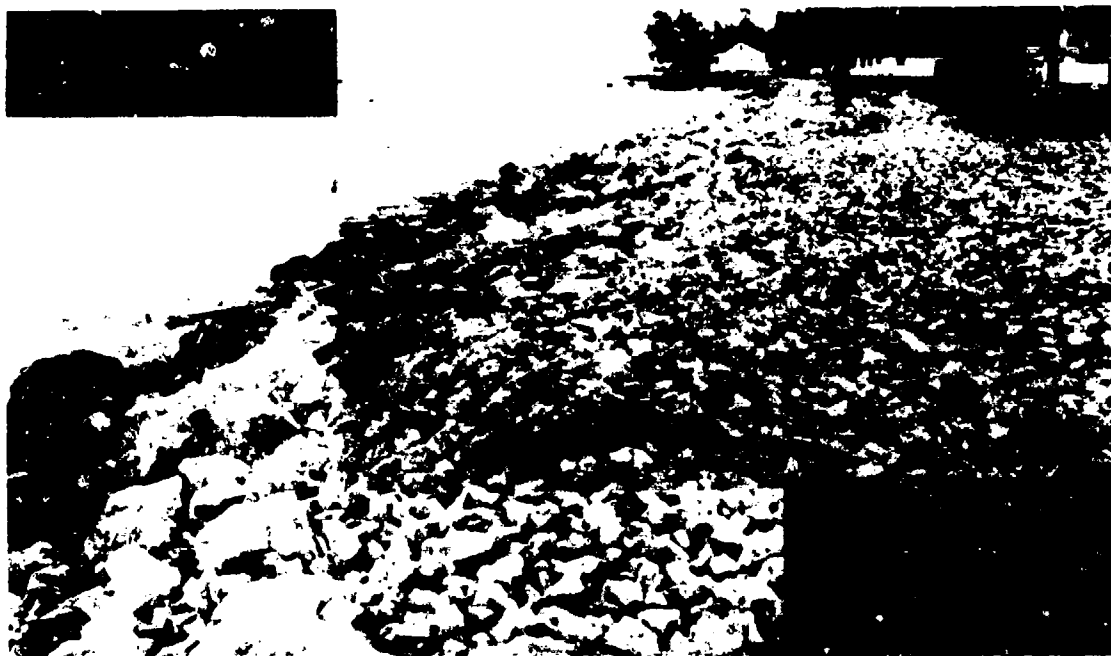
Figure 2-506. South end of revetment, Tawas Point, Michigan, 9 October 1979.

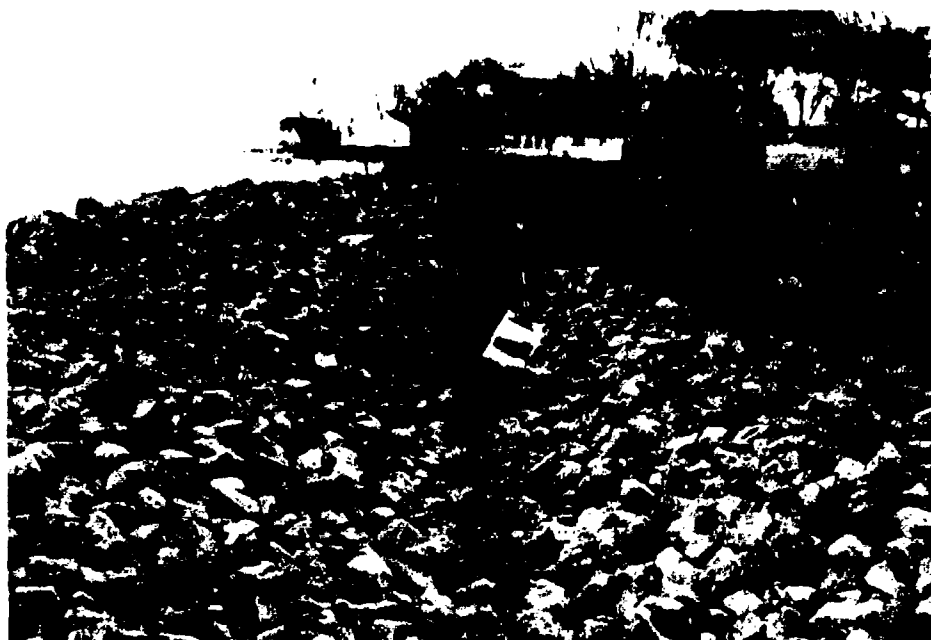
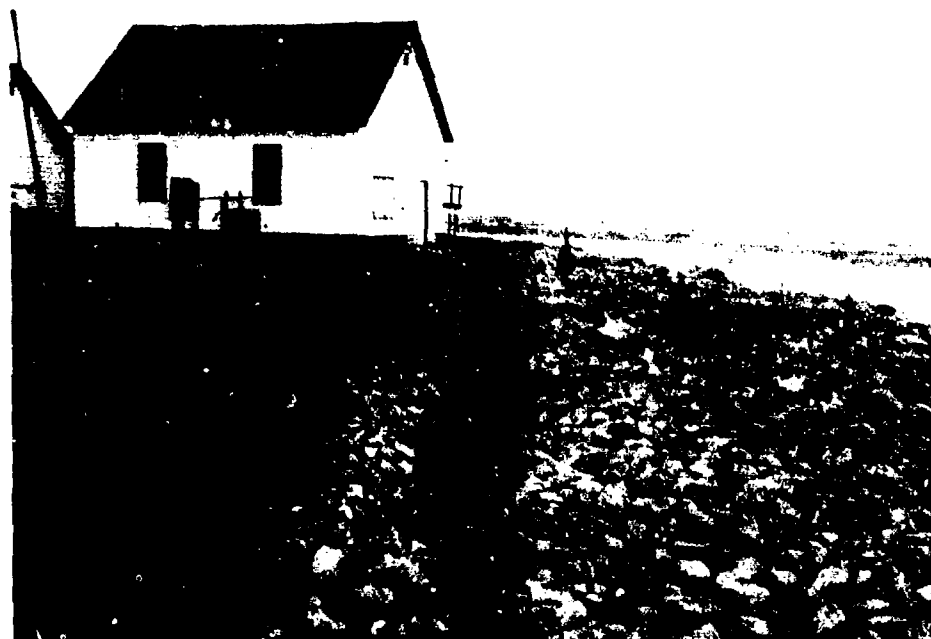
(3) Performance. Although only minor storms occurred during the first 2 years, slight slumping and shifting of the rock was evident. At the conclusion of monitoring by the State of Michigan in 1976, the structure was considered to have been very effective in protecting the shoreline. Although slight additional movement of rocks occurred after 1976, the rock revetment is still performing well, preventing further shoreline recession at the site. When monitoring under the Federal program began in September 1979, little further shifting of the rocks was apparent; however, in October 1979, a shallow depression (about 3 to 6 inches deep) along the landward edge of the revetment was noted (Fig. 2-506). This was apparently due to a slight settlement or shifting of rocks along the back of the revetment. On 26 November 1979, 39-knot winds from the south-southeast produced waves 8 feet high at the Tawas site (compared to an average sustained wave height of 4 feet during the 2 weeks before the initial visit on 4 September 1979). The 5 December 1979 visit revealed no significant changes since the October visit; this very effectively demonstrated the structural adequacy of the revetment. By 4 January 1980, the depression along the landward edge of the revetment had deepened to about 1 foot (Figs. 2-508 and 2-509). At

Figure 2-508. Looking south at depression along back of
revetment, Tawas Point, Michigan, 4 January
1980.

Figure 2-509. Looking north at depression along back of
revetment, Tawas Point, Michigan, 4 January
1980.

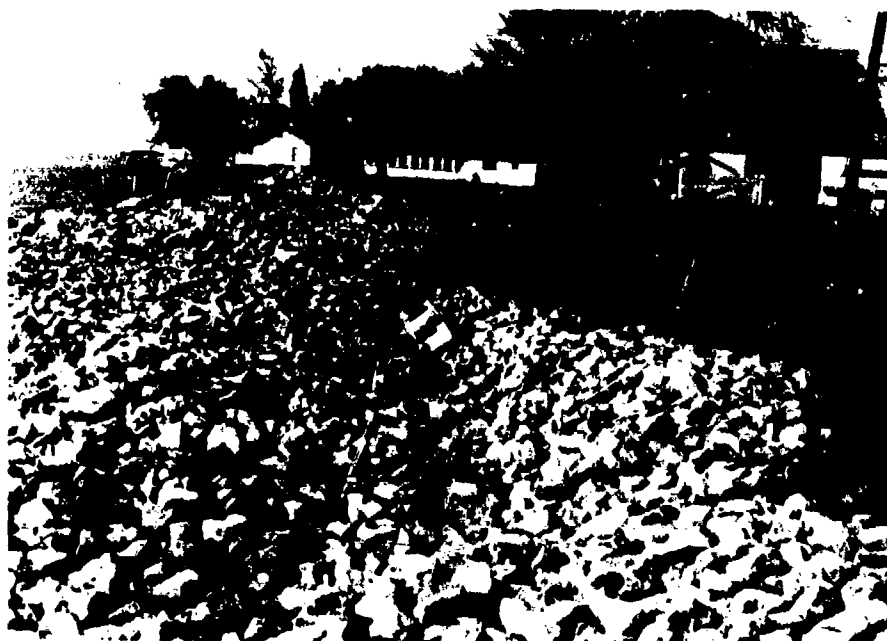
After the ice breakup in March 1980, the condition of the revetment had changed slightly. The slope along the north end appeared steeper than in previous observations. This change in slope may have resulted from shifting of the larger rocks at the toe of the structure. The depression along the back of the north end of the revetment deepened to approximately 1.5 to 2.0 feet (Fig. 2-510). Figure 3-44, which was put in Section III for comparison of similar devices, shows a series of profiles through the Tawas Point revetment. The accretion occurring in front of the structure and settlement along the back of the revetment are evident in the 1980 profile.

(4) Analysis. The rock revetment at Tawas Point demonstrated an ability to withstand more than 5 years of wave exposure, and it prevented further erosion of the sand bluffs. Although the depression along the back of the revetment was probably a result of the extreme wave heights, the structure sustained no significant damage and remained functionally effective. It is questionable whether the trench filled with filter stone at the top of the revetment was necessary. Otherwise, the design of the revetment section in the north half of the structure closely followed current state-of-the-art practice for good rock revetment construction. Many coastal engineers contend that the stone size in the armor layer and the layer thickness may be made progressively less from the highest point of direct

Figure 2-510. Depression behind the north end, Tawas Point, Michigan, 12 May 1980.

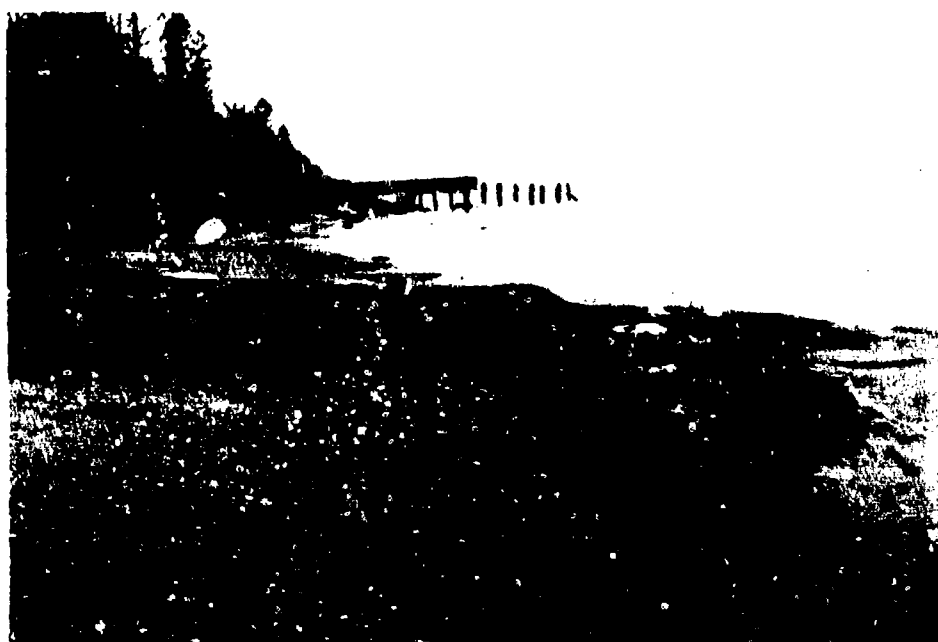
Figure 2-525. Two 40-inch-diameter Longard tubes, Sanilac Section Michigan, 26 December 1979.

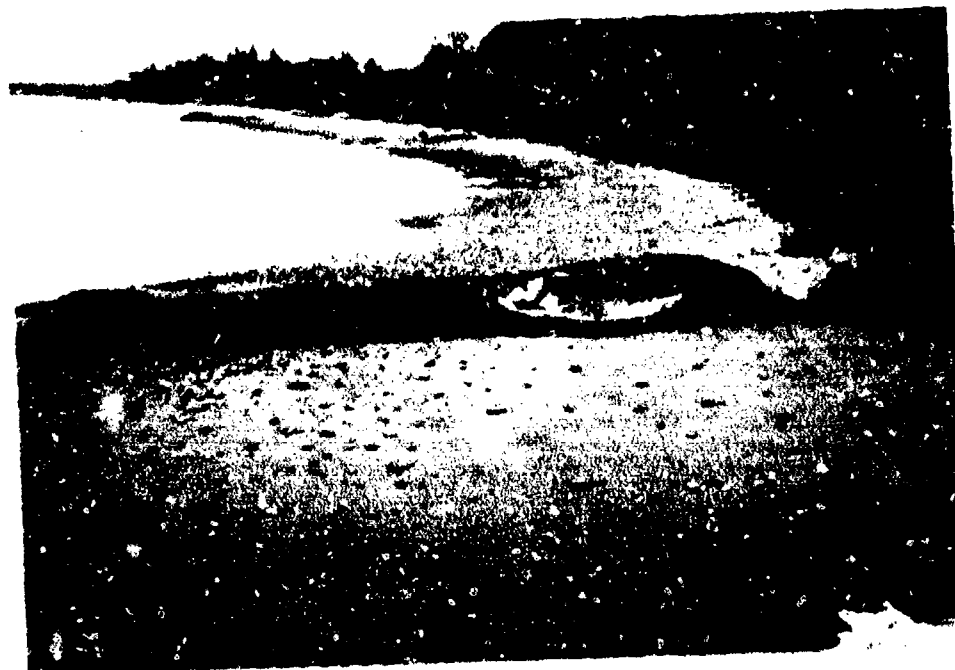
Figure 2-526. Tear in northern 40-inch-diameter Longard tube, Sanilac Section 26, Michigan, 26 December 1979.

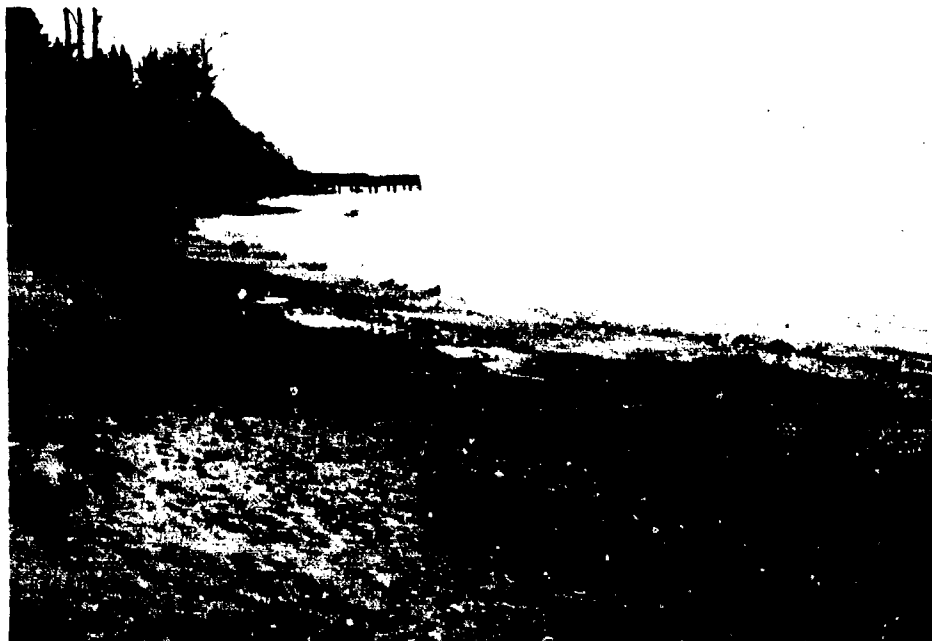
Figure 2-529. Loss of sand from 69-inch-diameter Longard tube, Sanilac Section 26, Michigan, 26 December 1979.

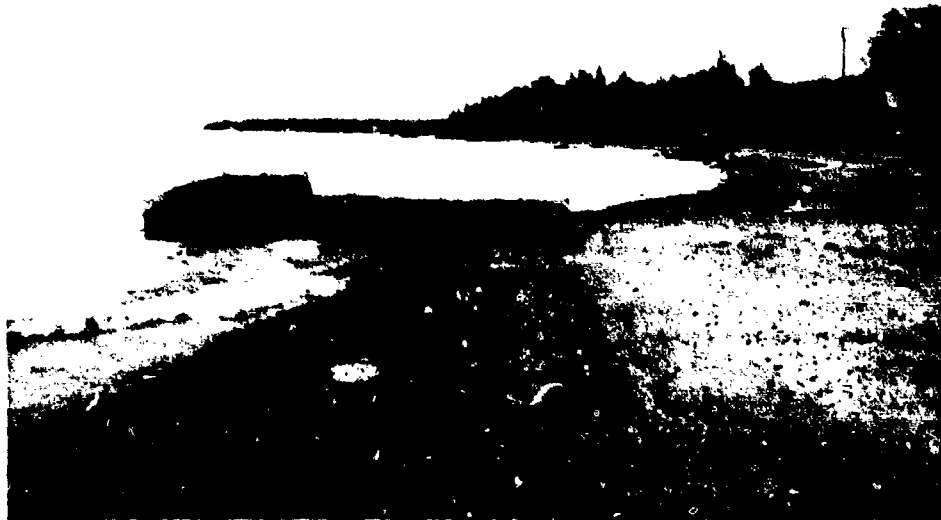
years after installation, was due primarily to the tendency of the bluff material to adjust to a more stable slope. Bottom scour at the lakeward end of the gabion groin increased to the extent that this section of the groin began to collapse in fall 1979 (Figs. 2-531 and 2-532). Settlement of the rockfill inside the baskets was evident at that time. Although the bluff was unstable and slumping was evident at the November 1979 visit, both the beach and bluff were farther lakeward at this structure than on the downdrift side (Fig. 2-523). This was considered indicative of the effective performance of this structure. In December 1979, the beach profile appeared to be about 0.3 foot lower to the north and up to about 0.5 foot lower to the south of the structure than it had been during the previous visits. No additional bluff slumping was evident at the December visit. The first two tiers of baskets were fully exposed, and the third tier was exposed on the south side. In May 1980, the beach profile was 0.5 foot higher to the north and 1.0 foot higher to the south of the structure.

Figure 2-531. Collapse of lakeward section of gabion groin, Sanilac Section 26, Michigan, 27 November 1979.

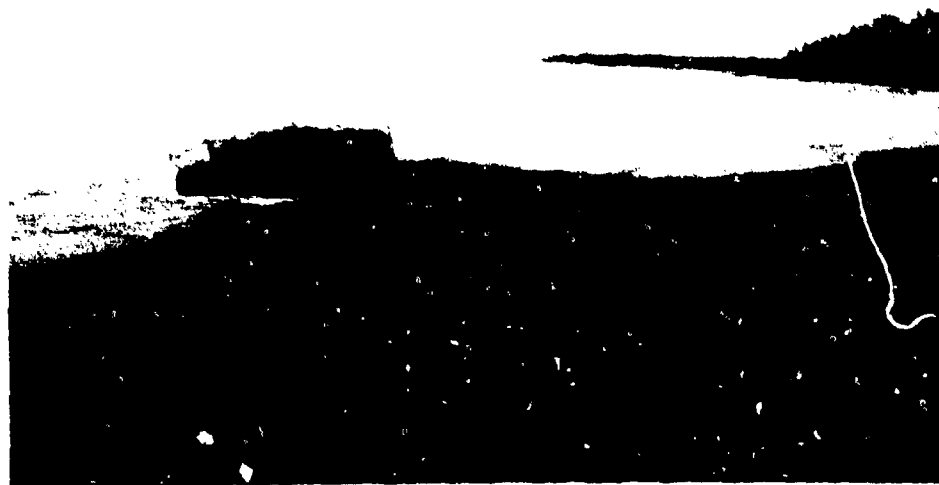
Figure 2-532. Loss of rock from collapsed section of gabion groin, Sanilac Section 26, Michigan, 26 December 1979.

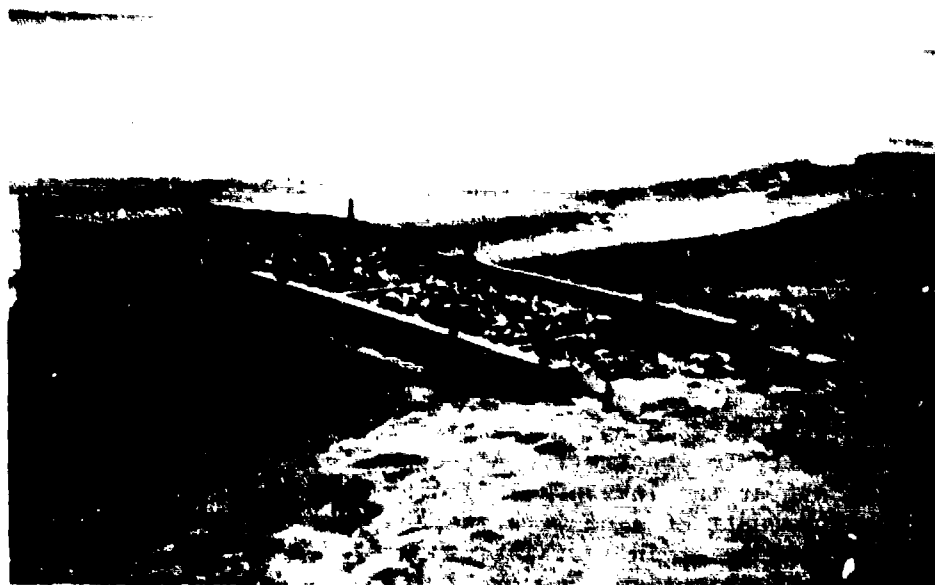
(b) Performance. The effectiveness of the timber-crib groin was not assessed by the State of Michigan because of insufficient monitoring time. The November 1979 visit by the District monitor revealed that the rockfill level at the lakeward end was about 1 to 1.5 feet below the top of the crib (Fig. 2-537). This could have resulted from settlement, loss of rock due to wave action, or vandalism. By December 1979, rocks in the lakeward section were about 2 feet below the top of the crib (Fig. 2-538). The crib was exposed only to midbeach in November 1979, but 1 month later it was exposed back to the toe of the slope, indicating a lower beach profile. The bluff appeared to be stable. By April 1980, the beach had narrowed significantly, especially north of the groin. By May the beach

Figure 2-537. Settlement or loss of rockfill from timber-crib groin, Sanilac Section 26, Michigan, 27 November 1979.

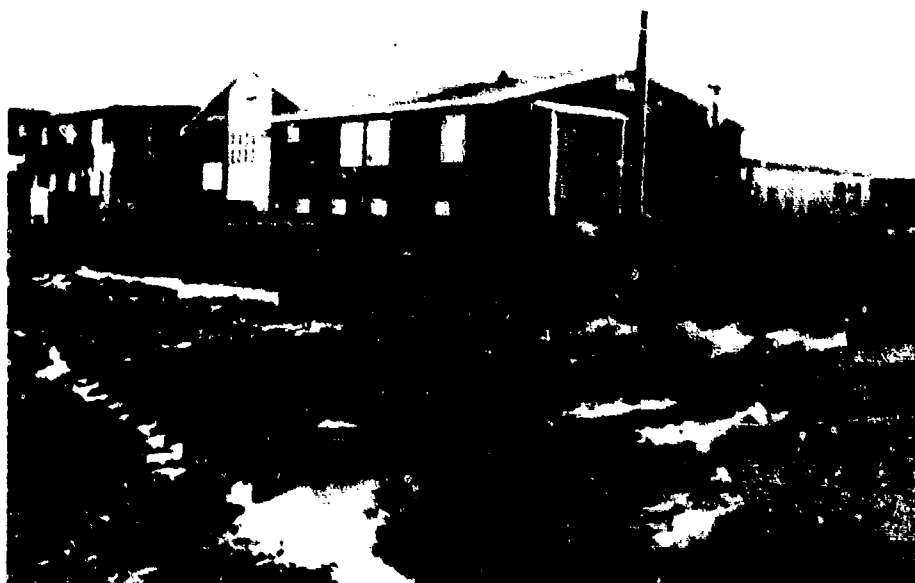
(a) Barrel Revetment. Construction of the 200-foot barrel revetment was nearly completed in September 1978 when inclement weather forced cessation of work for the winter. Many of the barrels needed to be filled to the top with sand and gravel, or capped on the upper tier (Figs. 2-546 and 2-547). The tiers were connected with four perpendicular diaphragms to create three closed cells with two open ends (upper Figure 2-543). By June 1979, considerable littoral drift was accumulating on the south side of the southern diaphragm. Some gravel collected on the south sides of the remaining diaphragms, and minor erosion occurred on the downdrift sides of all diaphragms. The two northernmost cells showed evidence of beach sand and gravel filling in behind the seaward shore-parallel double row of barrels (Fig. 2-548). The tops of three of the uncapped barrels were deformed by ice pressure or debris impact. The barrels were located on the seaward row, two from the north end (Fig. 2-549), and one from the center north diaphragm (Fig. 2-550). The proposed sandbag caps were deleted from the construction schedule, and beach gravel alongside the revetments was used to top off the barrels. The construction was completed in August 1979. No other changes in structural alignment, material, or cross section were observed. The accretion and depletion patterns also remained unchanged through October 1979.

Figure 2-547. Barrel revetment shortly after initial construction, Kotzebue, Alaska, 12 October 1978.

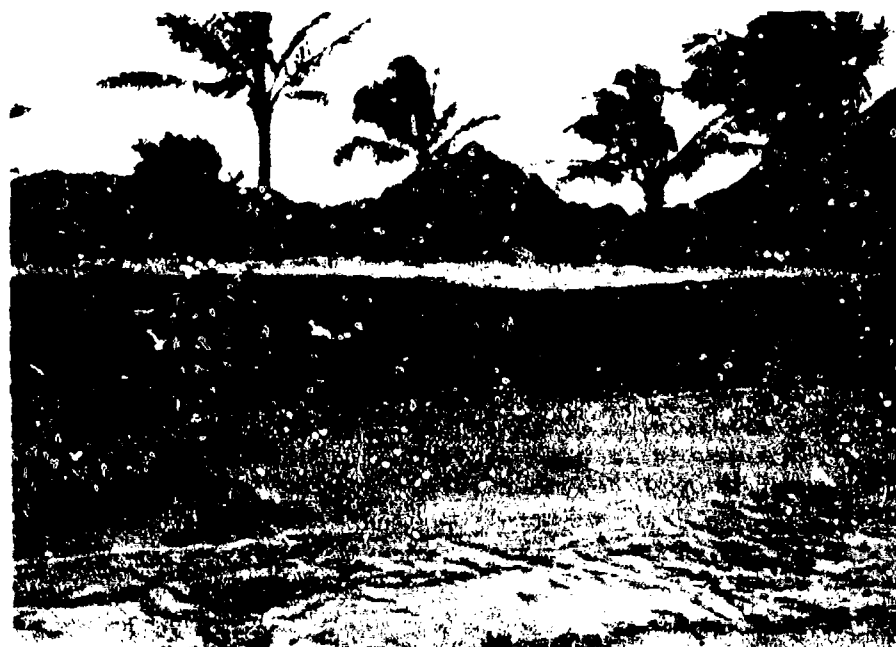
Differential settlement of individual blocks continued over the following 18 months. Although the tie rods were loosening and many of the blocks on the seaward face broke, the structure ceased to rotate. By January 1979, four blocks had been damaged--two near the south end were vertically displaced, and two near the center of the structure had broken away (Figs. 2-603 and 2-604). By May 1979 most of the tie rods were rusted and loose, and in November 1979 several blocks in the seaward face were broken apart (Figs. 2-605 and 2-606). Despite this component damage, the Sandgrabber remained functionally effective.

Figure 2-604. Displaced blocks lying in sand along mid-section of the structure, Kauloa, Hawaii, 4 January 1979.

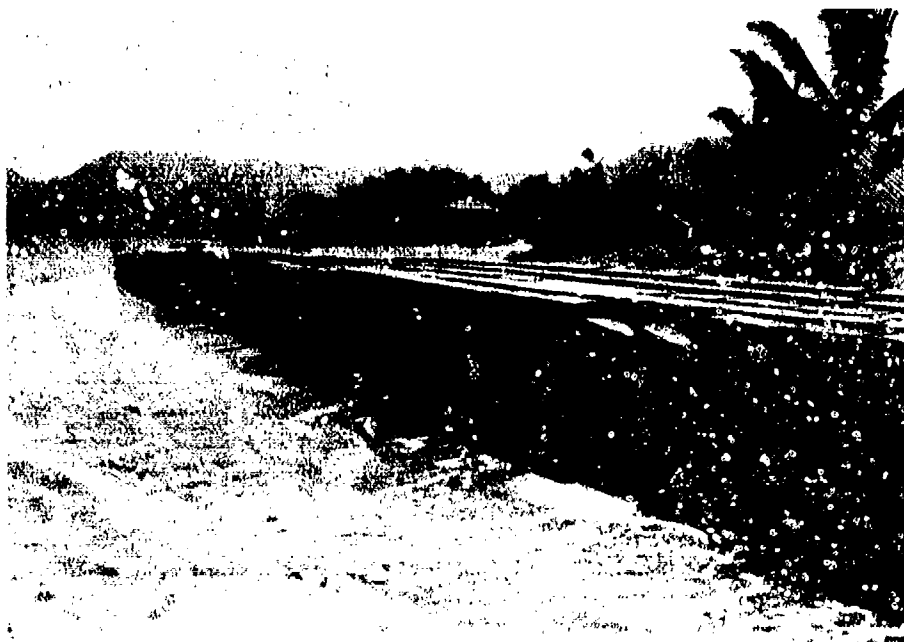
Figure 2-605. Broken blocks viewed from midsection of structure, Kualoa, Hawaii, 8 November 1979.

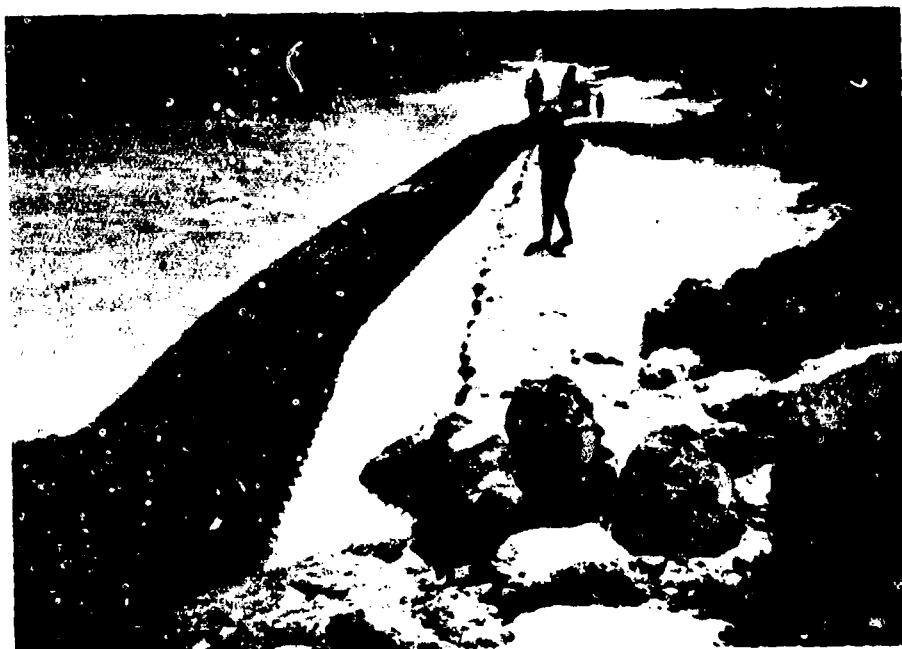
(4) Performance. Generally, the concrete blocks and galvanized-steel tie rods of the Sandgrabber withstood the natural forces of waves and tides. Some settlement was detected about 1 week after installation, but there was negligible differential shifting of individual blocks. One block and one tie rod were broken at the north end as the structure settled against the adjacent revetment stone (Fig. 2-619). Over the next 5 months, the structure continued to settle, rotating downward on the seaward side. This resulted in a few loose tie rods, but the blocks remained intact. During August 1979, the seaward settlement increased, with a seaward slope of 5° on the south end, 11° along the midsection, and 15° on the north end (Fig. 2-620). About eight blocks on the northern landside were broken apart by tension forces exerted by the tie rods as a result of seaward settlement (Fig. 2-621).

Figure 2-620. Seaward settlement of Sandgrabber, Bellows Beach, Hawaii, 5 September 1979.

Some structural performance problems developed at this site which a few comments might help to mitigate at future installations. First, since the sand at Bellows is fine grained, the settlement of the seaward side of the structure due to toe scour should have been anticipated, and bedding should have been provided or the foundation trench should have been excavated to the anticipated scour depth. Second, the Sandgrabber is not sufficiently flexible; it can be damaged by uneven settlement. This was clearly demonstrated at this site by comparing the north and south ends of the installation (Figs. 2-627 to 2-630). At the north end, the Sandgrabber settled on the adjacent, existing coral rock revetment and, due to inflexibility, was unable to conform to the scouring bottom (Fig. 2-630). As a result, the north end of the structure was damaged. This problem might have been avoided had the structure not settled as much, had the structure been more flexible, or had the north end of the Sandgrabber not been constructed such that it settled onto the rock structure. Third, if differential settlement of the Sandgrabber is anticipated, elastic "ties" of some sort might be substituted for the steel tie rods. This would eliminate the breaking of blocks that results from excessive stresses due to inflexibility of

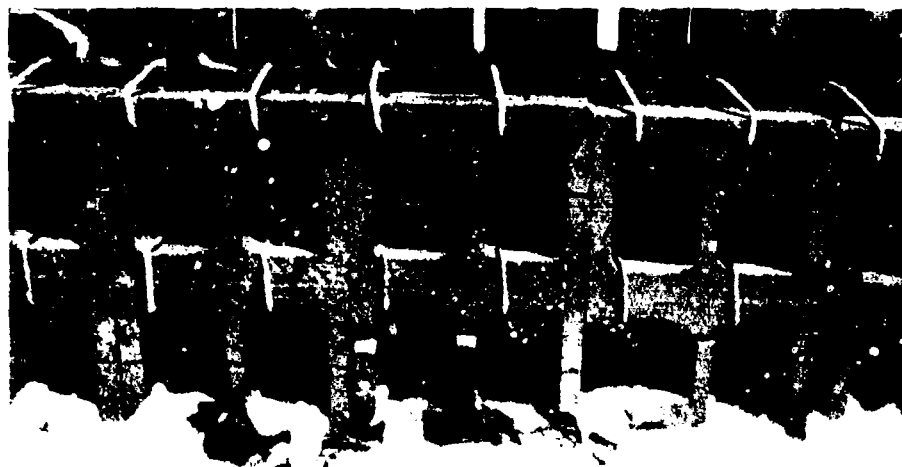
Figure 2-621. Broken blocks, landward side, Bellows Beach, Hawaii, 5 September 1979.

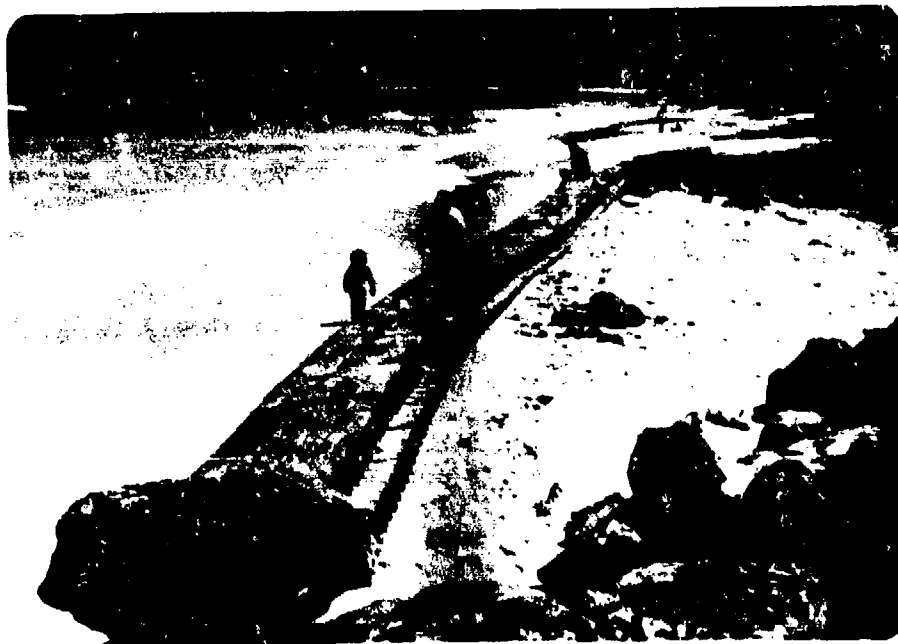
Figure 2-625. Scour beginning at the north end, Bellows Beach, Hawaii, 3 July 1979.

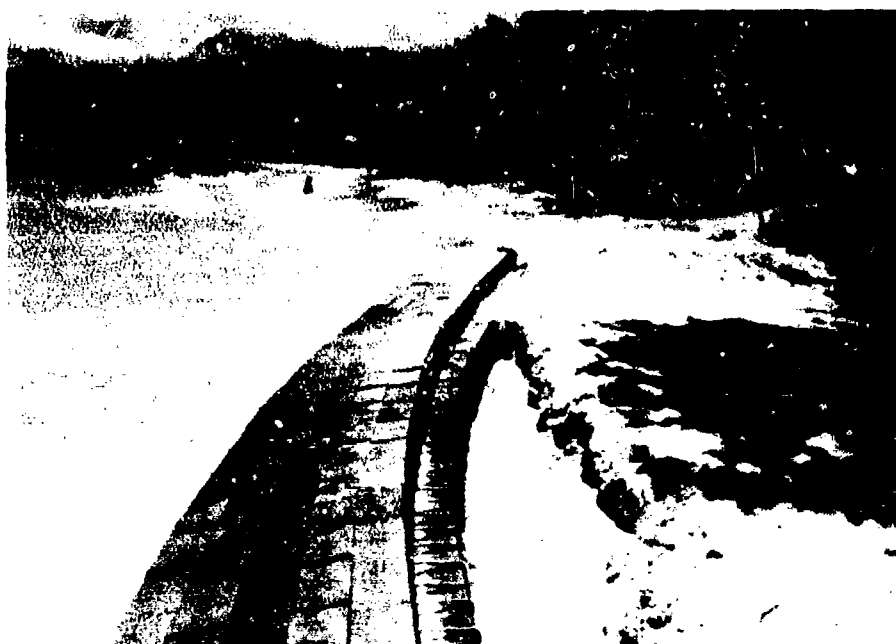
Figure 2-626. Trench working its way south landward of structure, Bellows Beach, Hawaii, 5 September 1979.

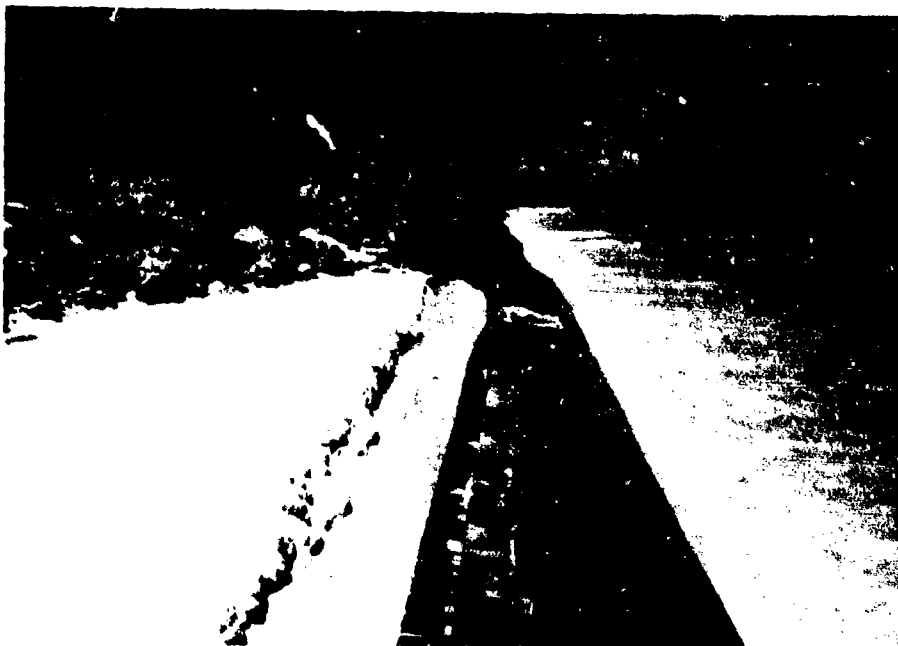
Figure 2-628. Scour trench along north end of structure, Bellows Beach, Hawaii, 5 September 1979.

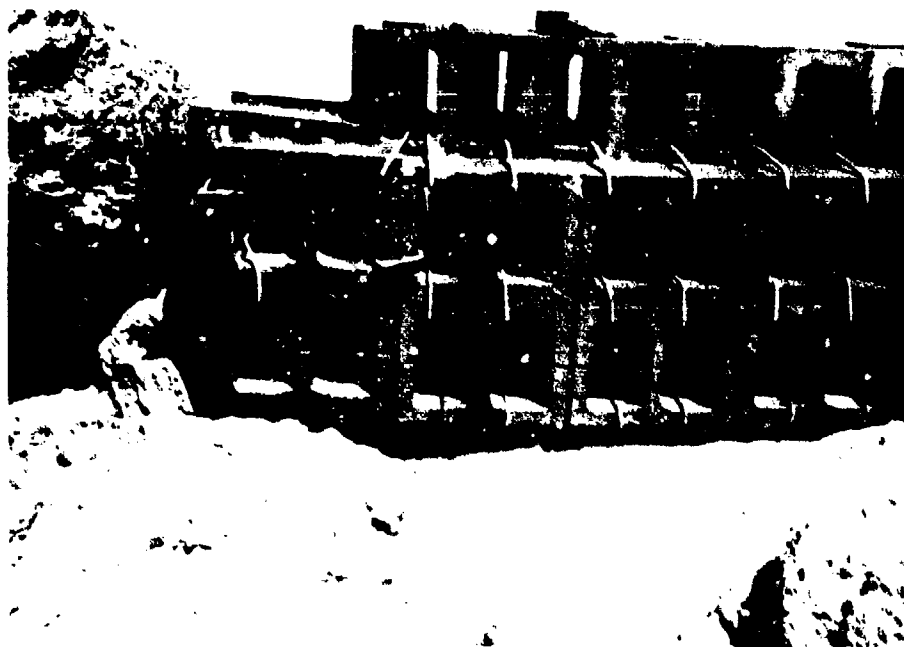
Figure 2-630. Landside of north end of Sandgrabber settling on the existing coral rock revetment, Bellows Beach, Hawaii, 5 September 1979.

(a) The Kualoa Sandgrabber suffered little scouring and settlement compared to the Bellows Sandgrabber. Scouring and settlement were more localized for Kualoa than for Bellows, where the Sandgrabber settled uniformly over its entire length. The sand is much coarser at Kualoa than at Bellows, therefore providing a better foundation. When the water level is high at Bellows, the sand probably fluidizes, allowing the structure to sink.

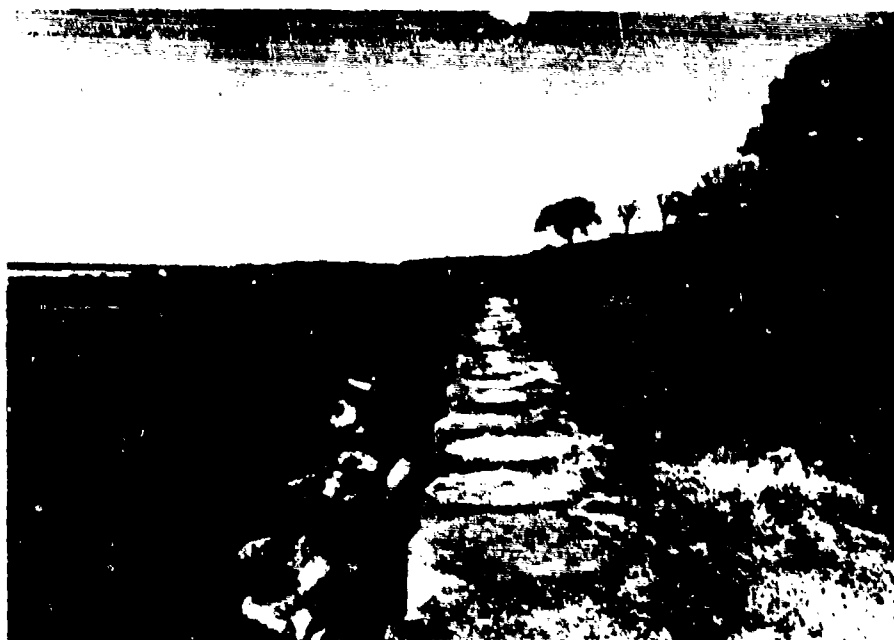
Figure 3-16. Concrete placed on top of and behind the pipe structure, McCollum Park, Beach City, Texas, 26 February 1980.

(4) Seal the tops of the pipe fills with about 2 inches of concrete grout to prevent washout by overtopping waves (Fig. 3-16).

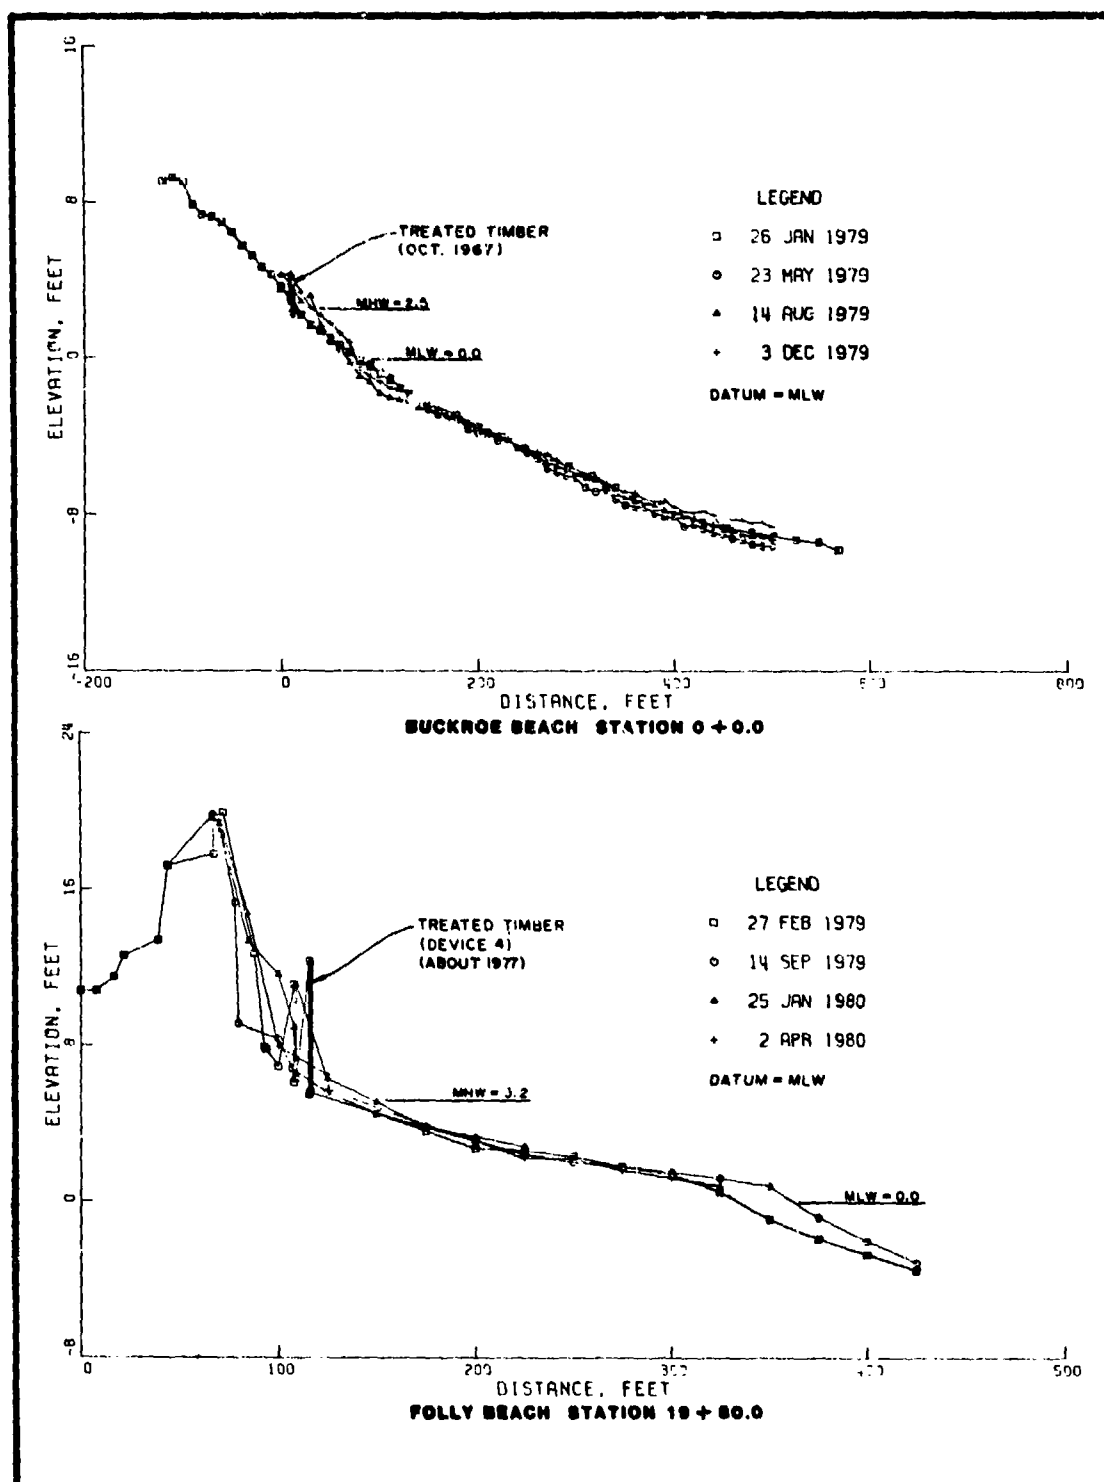
(1) Treated Timber. Profiles were compared at two sites where treated-timber bulkheads were monitored--Buckroe Beach, Virginia, and Folly Beach, South Carolina (Fig. 3-17). The bulkhead at Buckroe Beach was a timber sheet-pile structure which remained structurally sound throughout the monitoring period. This structure acted in conjunction with groins which maintained a protective beach berm that prevented waves from impinging directly on the bulkhead. The profiles show that the beach in front of the

At Folly Beach, the bulkhead was also of timber sheet-pile construction, and it also remained structurally sound throughout the monitoring period. It performed well until September 1979 when hurricane waves overtopped and washed large quantities of material from behind the structure. The profiles show the material lost in September 1979, as well as the material replaced by January 1980.

Figure 3-17. Profiles of treated-timber bulkheads.

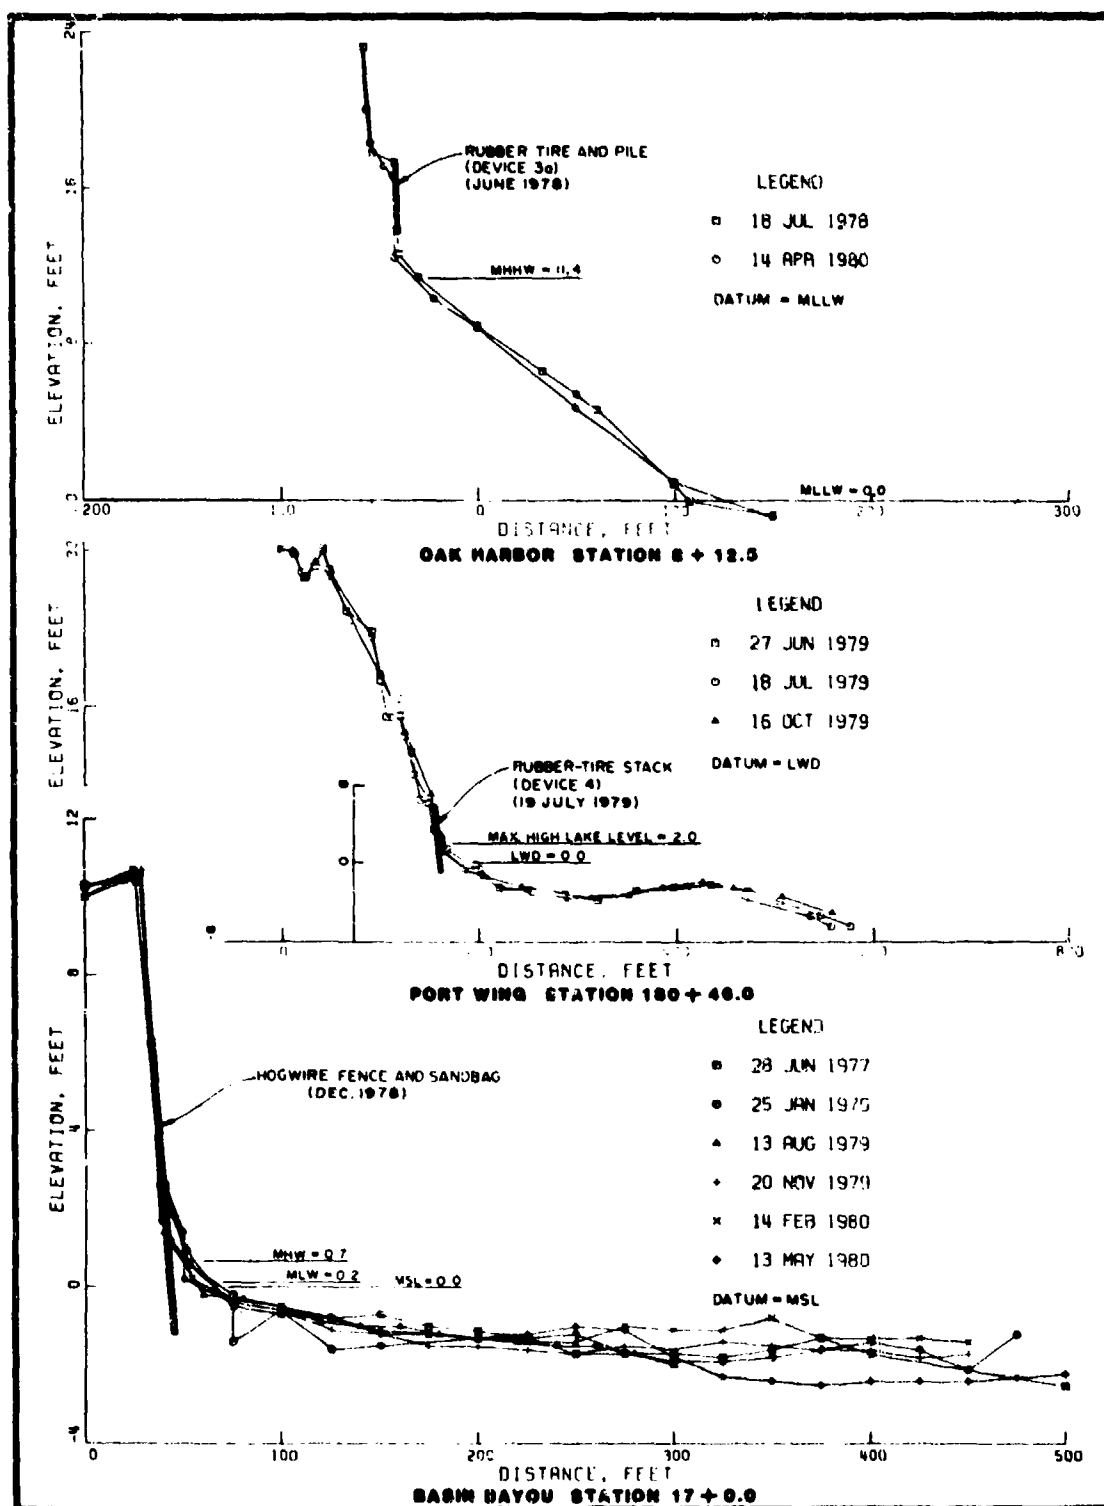
(2) Rubber Tire and Pile, Rubber Tire Stack, and Hogwire Fence and Sandbags. The profiles for these structures are shown in Figure 3-18. The rubber tire and pile bulkhead at Oak Harbor, Washington, despite being placed high in the tidal zone, was damaged by wave attack allowing the tires to collapse and settle and some of the gravel washed out. This damage did not seriously reduce its functional performance, as the profiles show that little material was eroded from behind the structure.

The rubber-tire stack bulkhead at Port Wing, Wisconsin, was progressively damaged by wave action. Despite the damage and the inability of this structure to sustain under wave attack, the profiles indicate that the structure did protect the upper bank from significant erosion.

Figure 3-18. Profiles of rubber tire and pile, rubber-tire stack, and hogwire fence and sandbag bulkheads.

The hogwire fence and sandbag bulkhead at Basin Bayou, Florida, was destroyed by Hurricane Frederic in September 1979 and the bank behind the structure was severely eroded. The erosion is not shown by the profiles because replacement fill was added before the profile was surveyed again. Without structural protection, another episode of high waves would surely cause measurable bluff erosion.

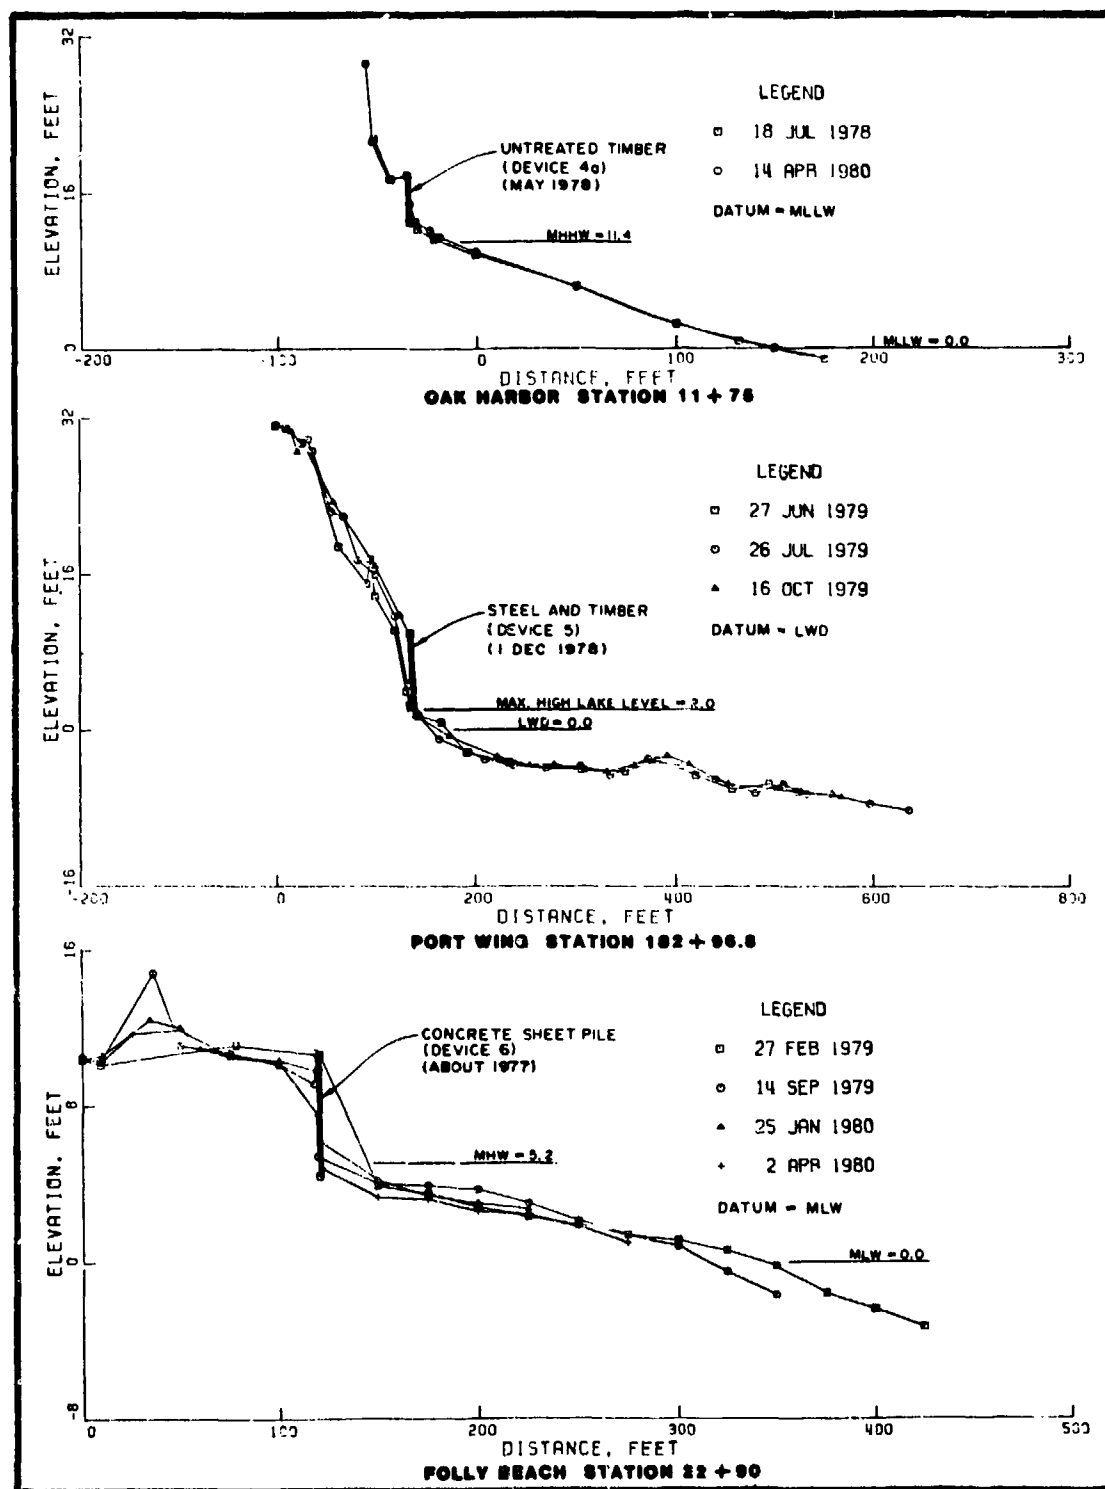
The untreated-timber bulkhead at Oak Harbor, Washington, was completely destroyed by wave action soon after its construction, and fill material behind the structure was removed. Figure 3-19 shows that although the structure was damaged and fill was lost, serious erosion of the bank behind it did not occur.

The steel and timber bulkhead at Port Wing, Wisconsin, suffered no damage during the monitoring period, and the profiles show that the structure adequately protected the bank, as no erosion was evident. The upper-bank aberrations in the profiles are due to grading work in progress. The bank was seeded in late July 1979.

The concrete sheet-pile bulkhead at Folly Beach, South Carolina, suffered some damage during Hurricane David in September 1979, and material behind the structure was removed by wave action, as shown by the profiles. New fill was later placed behind the structure, as shown by the April 1980 profile.

Figure 3-19. Profiles of untreated timber, steel and timber, and concrete sheet-pile bulkheads.

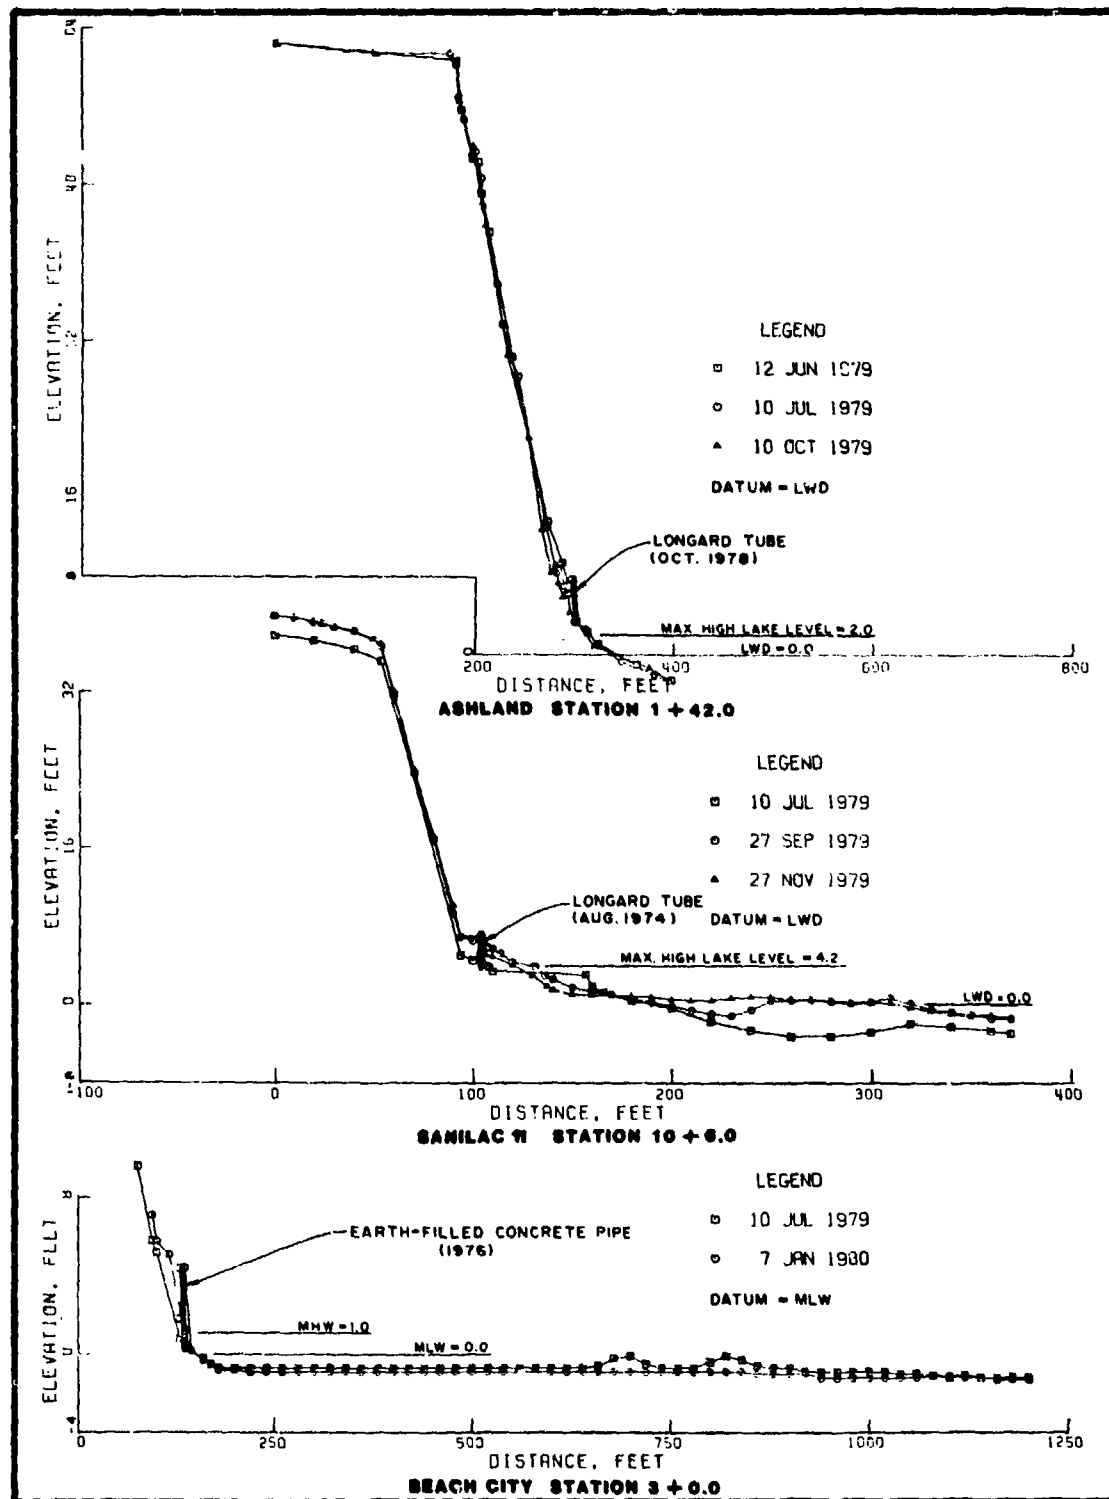
(4) Longard Tube and Earth-Filled Concrete Pipe. At Ashland, Wisconsin, the profiles are at the west seawall (device 9). Although this structure was damaged by debris and vandals it did not demolish the tube. In addition, the western end of the tube rolled slightly lakeward. The structure otherwise remained intact throughout the monitoring period. Figure 3-20 shows that some erosion occurred behind the structure, probably due to overtopping waves.

At Sanilac Section 11, Michigan, the Longard-tube bulkhead was placed in the middle of the tidal zone. This structure was moved lakeward, damaged, and eventually almost completely buried during the monitoring period.

The earth-filled concrete-pipe bulkhead at Beach City, Texas, was damaged in July 1979, and the bank behind the structure was eroded. The structure was rebuilt in November 1979 and new fill was placed behind it. The 6-month survey period was not long enough to determine the rebuilt structure's performance. The first survey shows the erosion caused by the storm; the second survey shows the profile of the rebuilt section.

Figure 3-20. Profiles of Longard-tube and earth-filled concrete-pipe bulkheads.
